DeatschWerks Technical Service Bulletin (TSB)

Bulletin No: TSB-17-04-14

Subject: DW300c Fuel Pump Install in 09-15 Cadillac CTS-V OE Pump Assembly

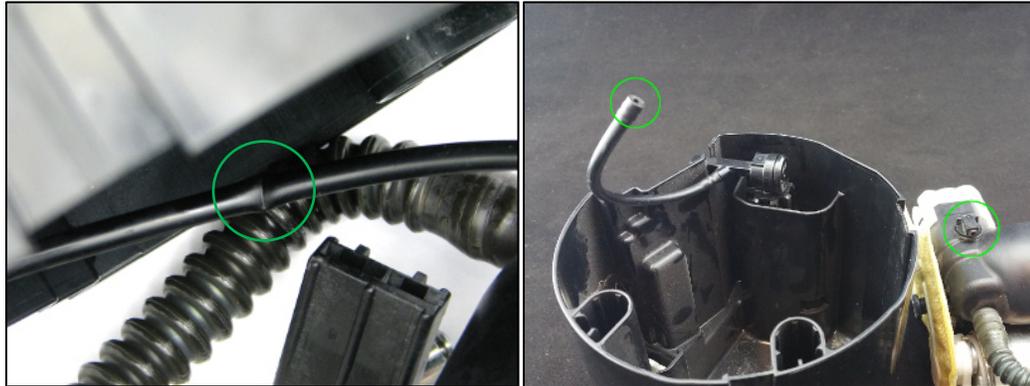
3. Venturi Supply Line Damaged:

During disassembly and reassembly, the small black plastic line that connects the center section of the pump assembly to the venturi pump on the bucket of the pump assembly is susceptible to damage. If the supply line is kinked, this could cause an issue with flow delivery to the venturi pump. As the venturi pump is what draws fuel into the bucket from both sides of the saddle tank, if the flow delivery to the venturi pump is compromised, the bucket may be emptied by the dual fuel pumps during low fuel level conditions. Further, the transfer of fuel from the other side of the saddle tank may be insufficient to completely transfer fuel from the non-pump side of the tank.

The port on the center section of the pump assembly is also susceptible to damage. Should the outlet be broken off, the venturi pump will no longer be driven and the pump assembly will not be able to keep the bucket full once the fuel level drops below the top of the bucket assembly. Further, there will be no transfer of fuel from the non-pump side of the saddle tank. Repair parts and repair service are available from DeatschWerks.
